# Pre-Demolition Asbestos Survey

Lake County Land Bank  
13070 Lake Drive, Yates Township  
90 East Parkdale Road, Yates Township  
6813 South Esther Road, Pleasant Plains Township  
Baldwin, Michigan 49304

Hamp, Mathews & Associates, Inc.  
Bath, Michigan

**August 13, 2024**

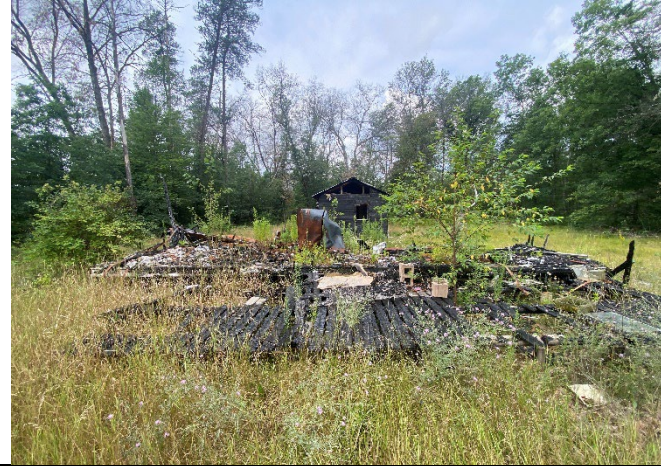
**Photograph #1**

Burnt front building on property

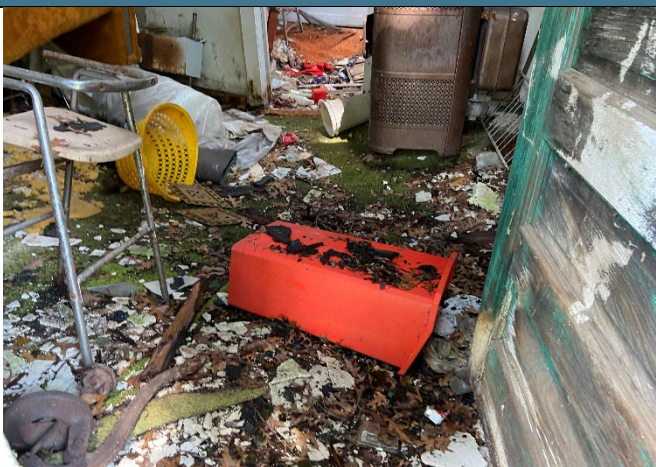
**Photograph #6**

Floors Collapsing

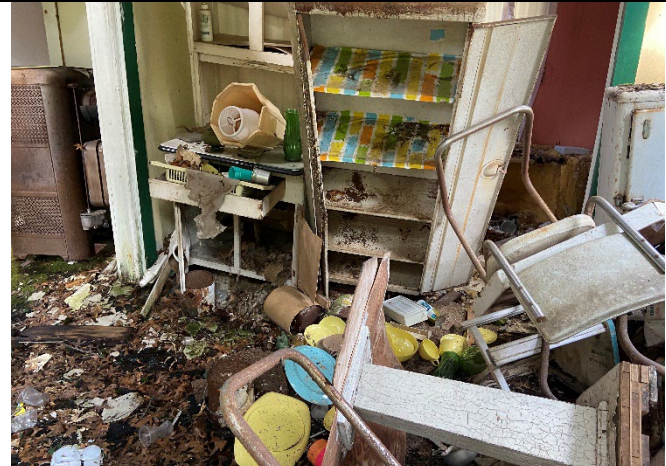
**Photograph #7**

Floors Collapsing

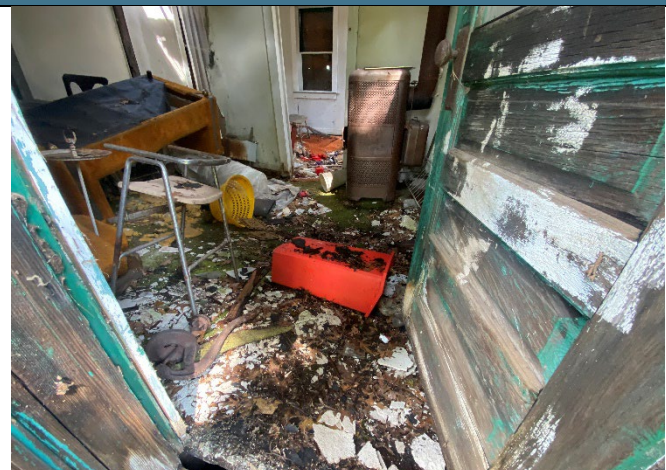
**Photograph #8**

Floors Collapsing

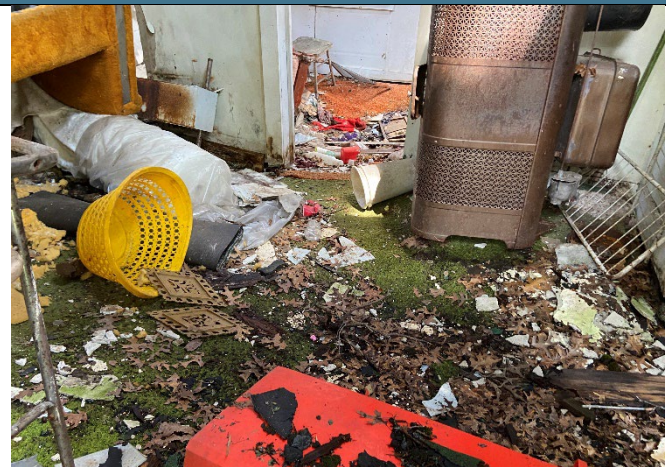
**Photograph #9**

Floors collapsing

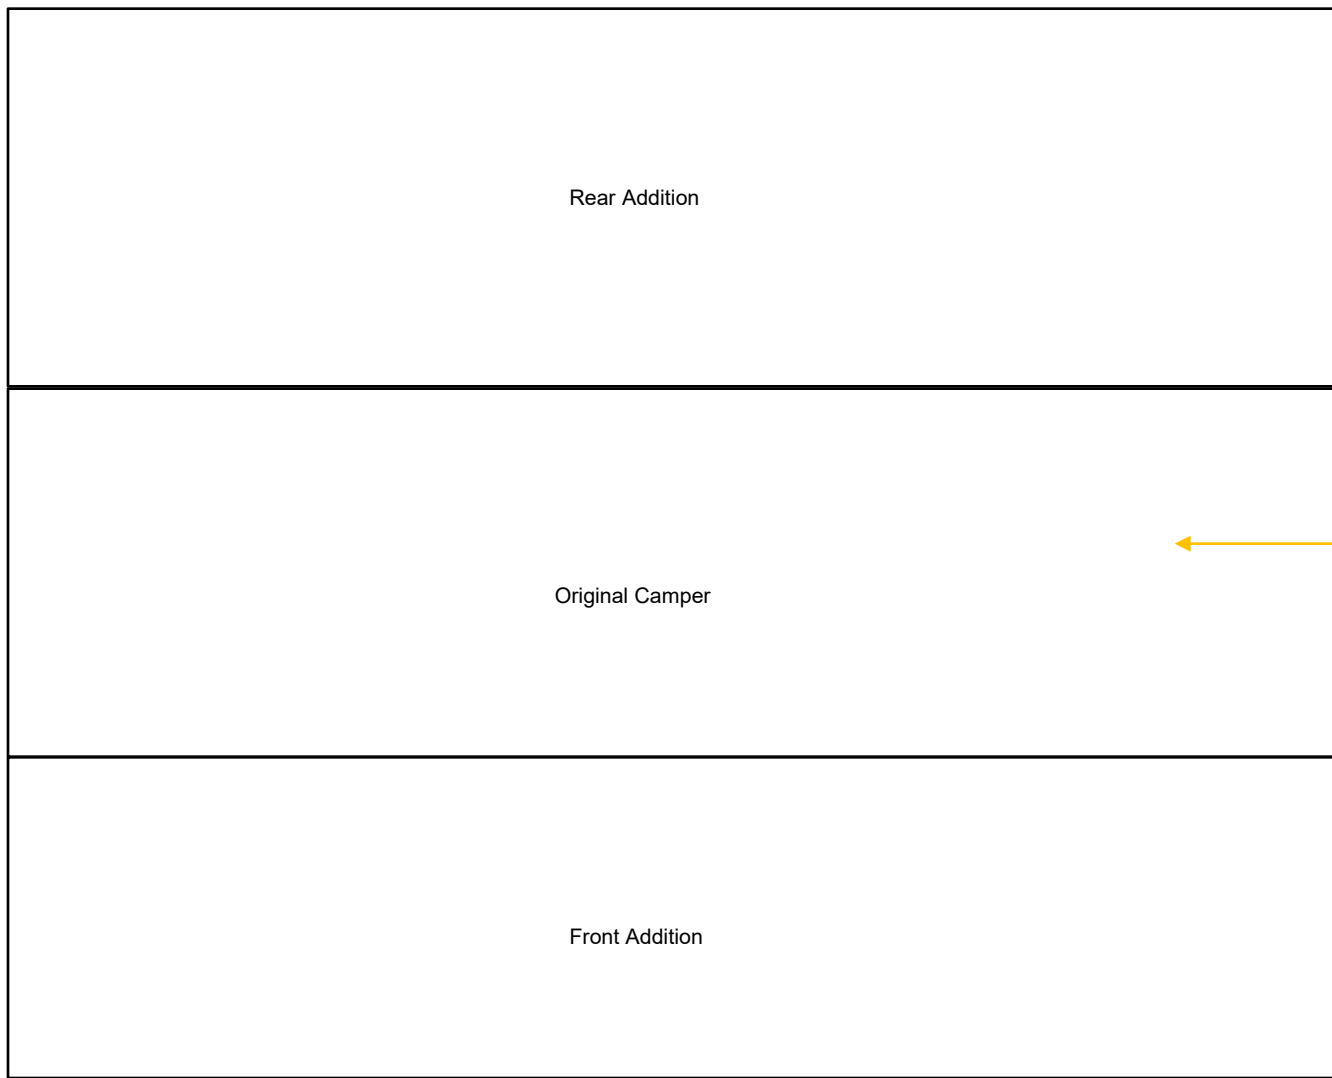
**ASBESTOS BULK SAMPLING  
SAMPLE LOCATION DIAGRAM**

**Original camper has two additions built on the front and the rear. A crawlspace was built around and under the camper and additions.**

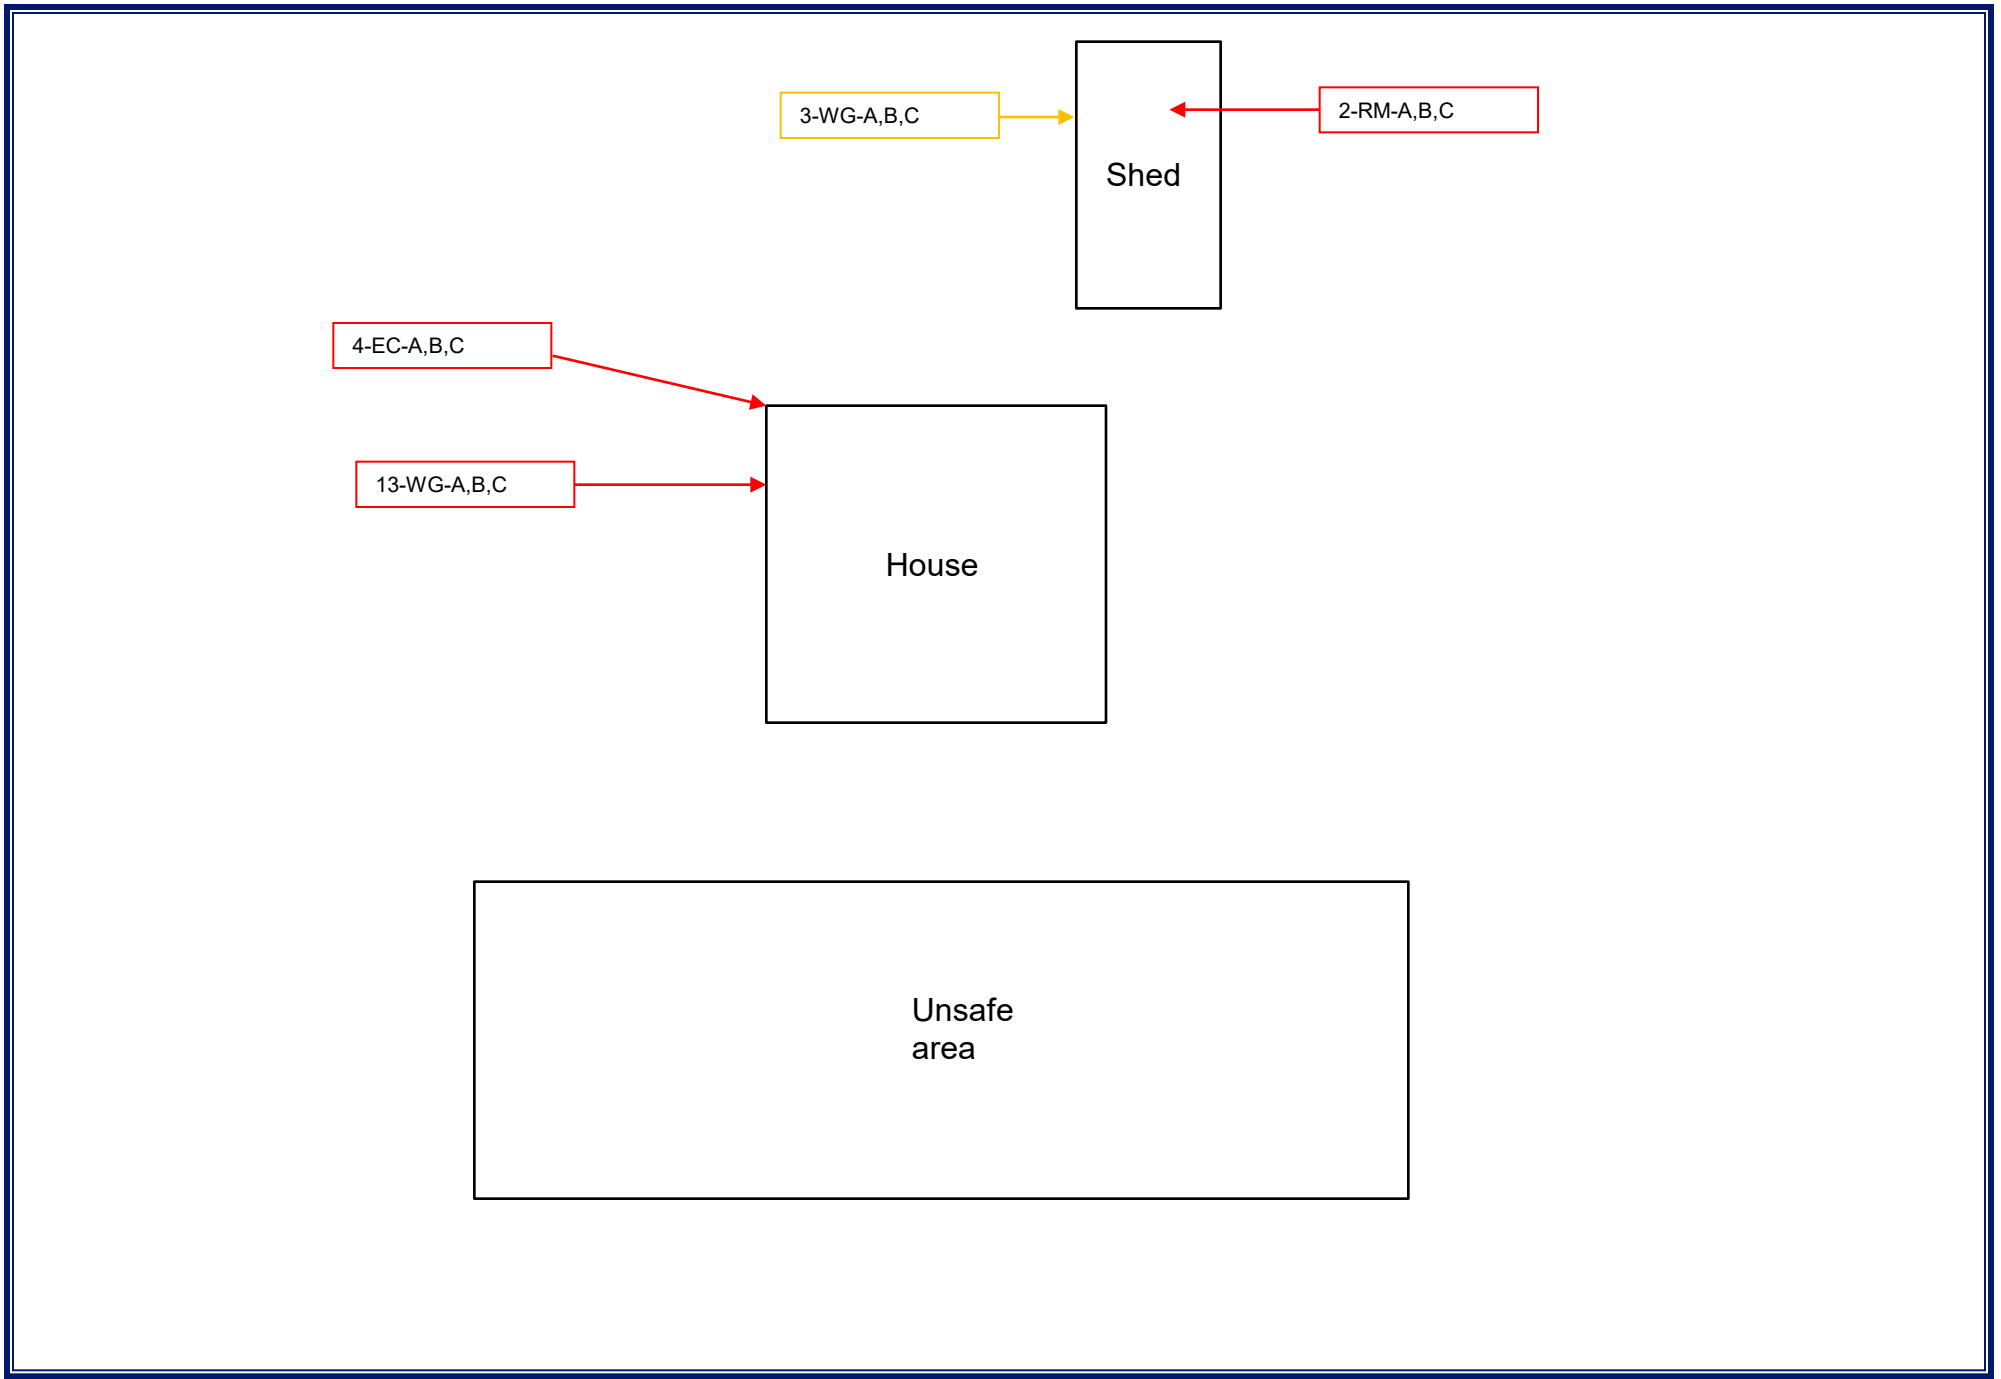
**ASBESTOS BULK SAMPLING  
SAMPLE LOCATION DIAGRAM**

**Front building unsafe to enter.  
Significant fire damage**

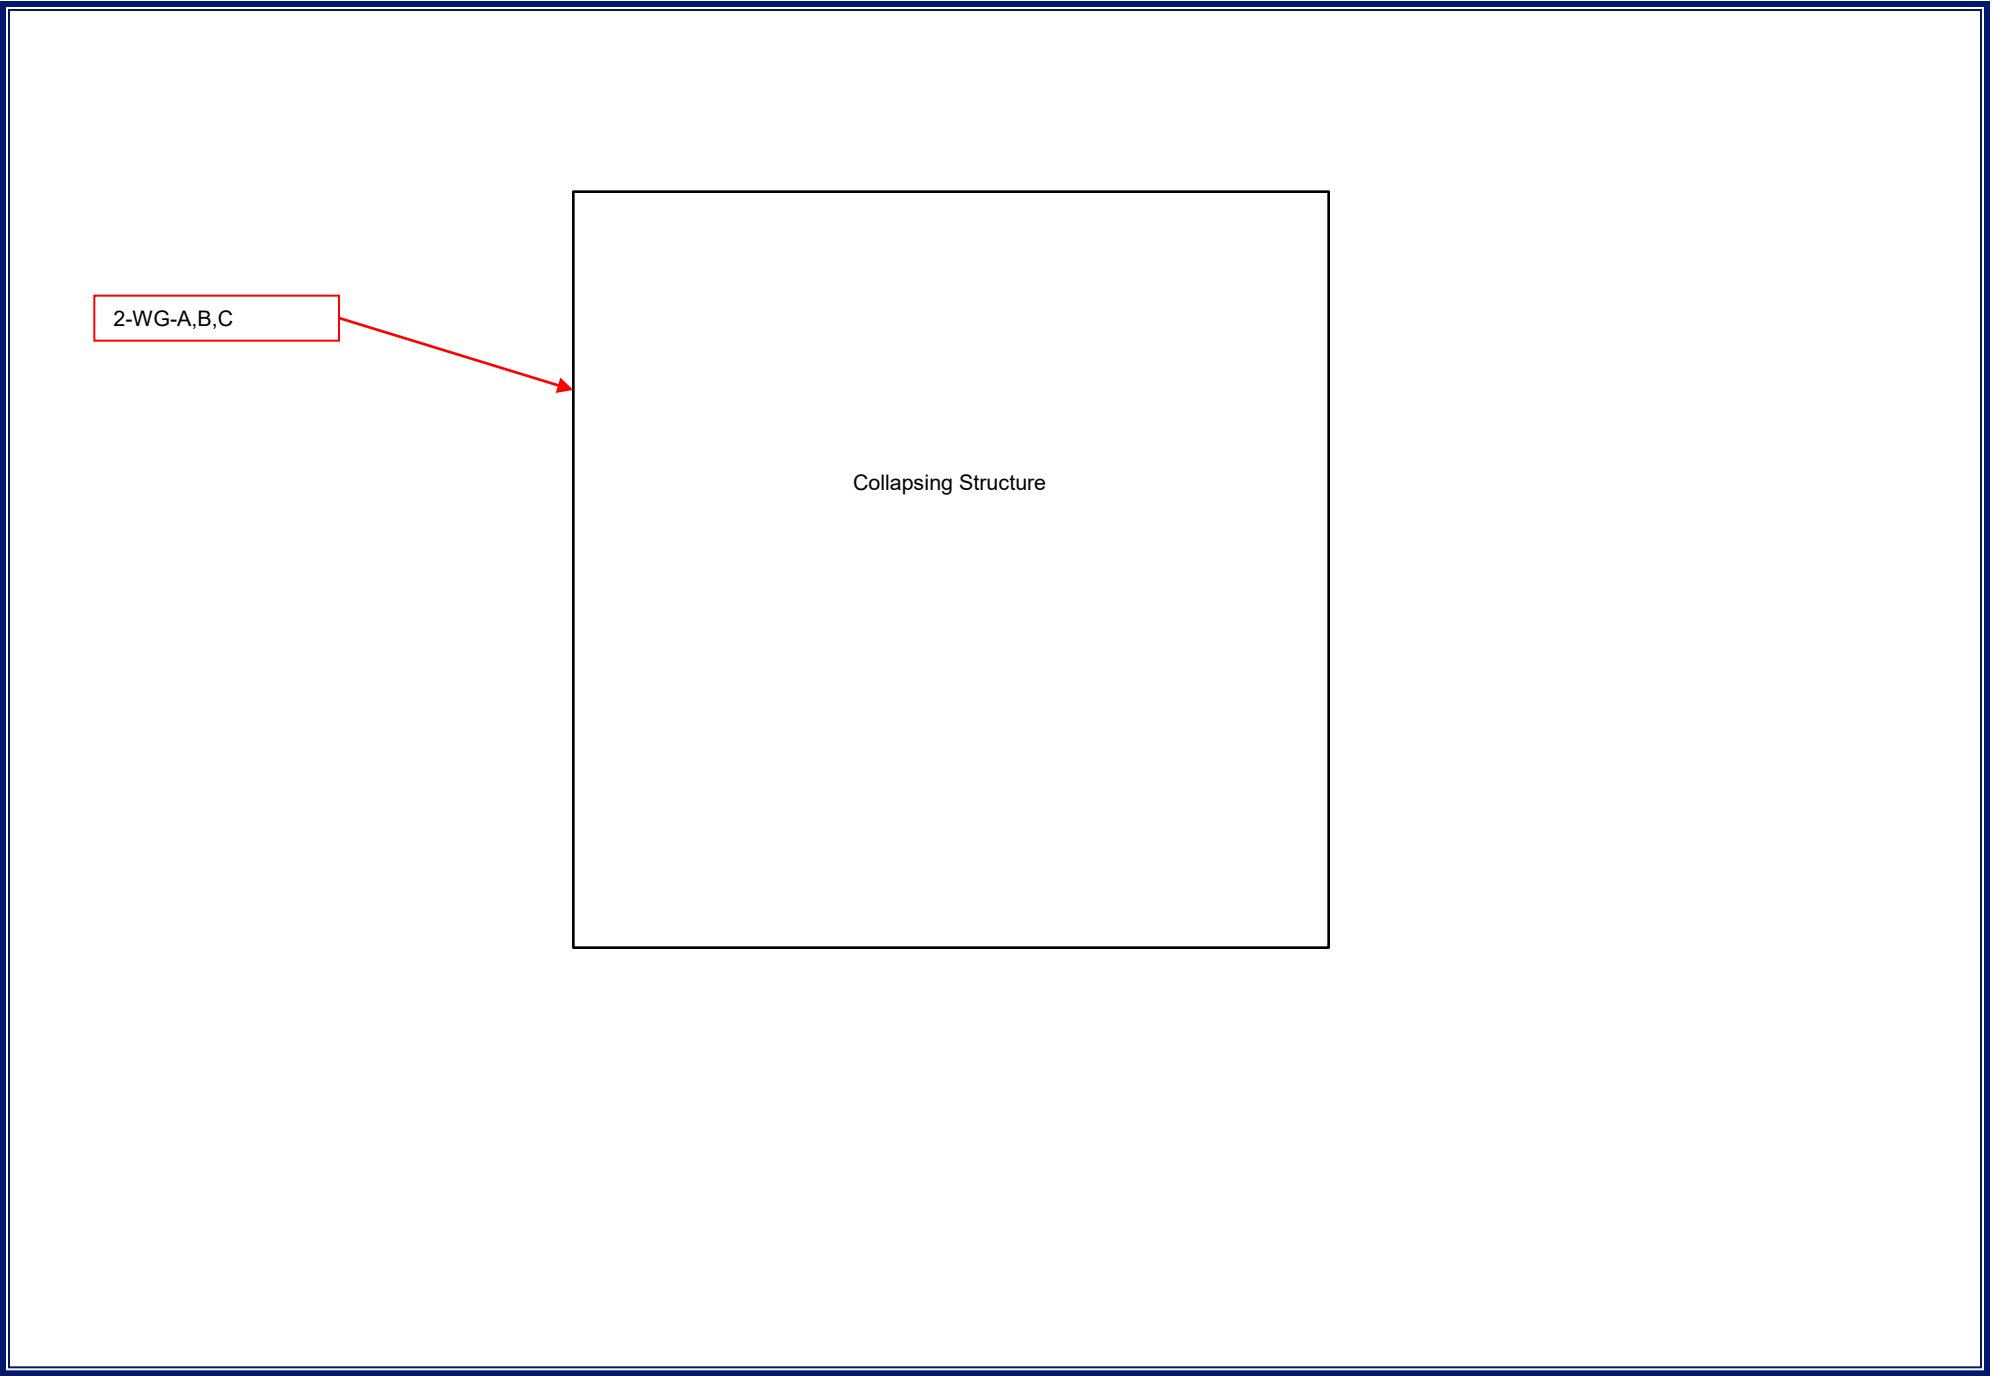
**ASBESTOS BULK SAMPLING  
SAMPLE LOCATION DIAGRAM**

**Parkdale unsafe to enter the building.  
Floors, walls and ceilings have begun to  
collapse**
